PB98-910404 NTSB/AAR-98/04 DCA97MA017

AIRCRAFT ACCIDENT REPORT

IN-FLIGHT ICING ENCOUNTER AND UNCONTROLLED COLLISION WITH TERRAIN COMAIR FLIGHT 3272 EMBRAER EMB-120RT, N265CA MONROE, MICHIGAN JANUARY 9, 1997

Adopted: November 4,1998 Notation 6997A/B/C

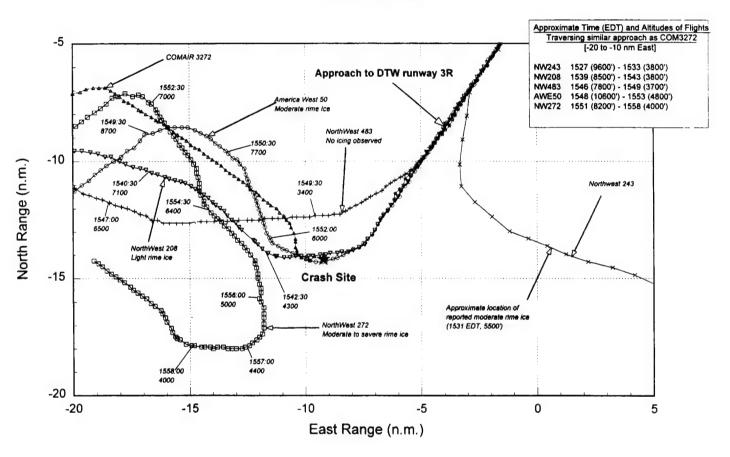
Figure 7.--Ground tracks of aircraft.

Relative Positions of COMAIR 3272 and several other flights using a similar approach 1/9/97, Monroe, MI

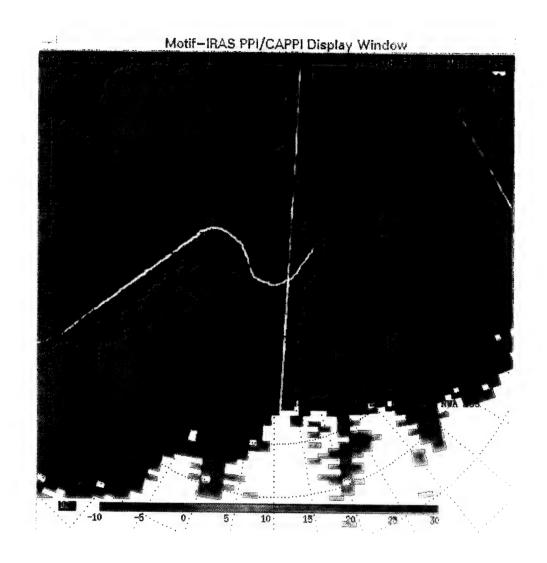
Figure 8.--Flightpath and weather radar echo information.

Doppler weather radar images from the National Weather Service weather radar at White Lake, Michigan. Image time is 2055:05Z. Ground tracks of Comair 3272 [red], Cactus 50 [yellow], Northwest 272 [blue], and Northwest 483 [black] plotted. Weather echo intensities [dBZ] color coded corresponding to color bar at bottom of images. Range rings every 10 kilometers. Azimuth radials every 10 degrees. True north to top of the image.

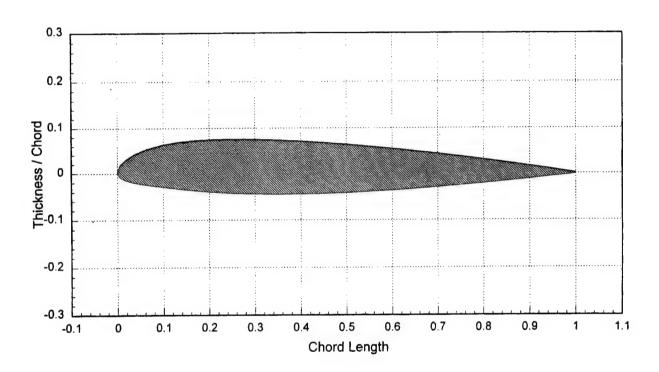
Figure 11.--Cross-section of a NACA 23012/23015 airfoil.

Both icing/wind tunnel tests used airfoil segments representative of the mid-to-outboard section of the EMB-120 wing—a National Advisory Committee for Aeronautics (NACA) 23015 to 23012 airfoil, 94 with leading edge deicing boots similar to the deicing boots on the EMB-120 wing. The UIUC airfoil was about a 1/3 scale model of the NACA 23012 airfoil installed near the wing tip of the EMB-120, with an aileron. The icing tunnel tests conducted at NASA-Lewis used a full-scale airfoil (representative of a section of the EMB-120 wing slightly inboard of the wing tip—a NACA 23014.5 to 23015 airfoil), with functional deicing boots. NASA's airfoil differed from the EMB-120 wing section slightly; most notably, the airfoil had a fixed-position aileron, and the deicing boot extended farther aft on the airfoil's lower surface. (Figure 11 is a cross-section of a NACA 23012/23015 airfoil, with deicing boot limits indicated.)

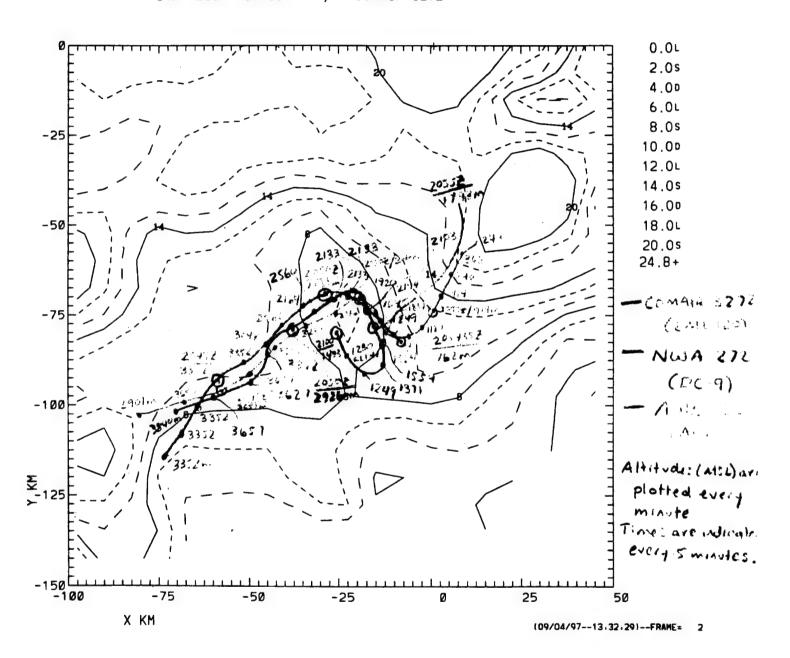
97/ 1/ 9 20 49 16-20 54 4 KDTX Z = 2.30 KM DZ (AS OF 09/04/97) ORIGIN=(0.00, 0.00) KM X-AXIS= 90.0 DEG DTX Radar Reflectivity - COMAIR 3272

A radar cross-section at 2.3 km MSL (Fig. 3b) reveals a slightly larger patch of < 10 dBZ reflectivity (compared to the size of the patch at 0.8 km) at the location of the first turn in the approach pattern. Comair-3272 had descended from 11,000 ft (3352 m - all heights MSL) at 2045 UTC and slowed from ~350 knots to ~240 knots before entering the first turn at 2050 UTC (see Table 3a). According to preliminary information from Embraer engineers, the airplane was "clean" until it descended to 7000 feet (~2133 m) MSL, and started to pick up drag at ~204945 UTC, possibly indicating the onset of ice accretion on the aircraft. Comair-3272 reached this altitude when it entered the patch of lower reflectivity at ~204904 UTC, held at 7000 ft until 205113 UTC, then gradually descended as it flew toward the southeast through the low reflectivity patch, reaching an altitude of 4000 ft (1219 m) by 205403 UTC. It was during this period that drag counts were reported to have increased, with the most rapid increase in drag counts indicated between 5500 and 4500 ft (1675 and 1370 m), according to Embraer engineers. Reflectivity values in the path of flight during this period of time were between ~4 and 9 dBZ. Once Comair-3272 descended to altitudes of 7000 ft or less, it flew through an area with reflectivity values of less than 10 dBZ for ~6 1/2 minutes (~5 minutes of which the aircraft was picking up drag, according to the preliminary engineering data - possibly in icing conditions) before attempting to make a left turn on approach to Detroit at 205426 UTC and 4000 ft (1219 m). During this portion of the flight, the plane was traveling at between approximately 160 and 180 knots in an environment where temperatures were between -6 and -11 C, according to the Detroit balloon borne sounding released at 2300 UTC. Total temperatures calculated for this period were between -3 and -7C.

NW 272 (a DC 9) also descended into the patch of low reflectivity at 7000 ft and made a right turn within it, essentially following the path of Comair-3272, but was about two minutes behind it (see 2050 UTC locations on Fig. 3b; Table 3b). NW 272 flew at similar altitudes at speeds of 150 to 170 knots, and, thus, had similar total temperatures to Comair-3272. The pilot reported that this was "the worst ice (the pilot) had seen all season" with some splashback and described the ice as "extremely heavy to severe" based upon "18 years of operations in the Detroit and Lake Erie areas." The pilot also reported that ice was accreting at a rate of approximately ½ inch of ice per minute, that the plane was flying in solid overcast conditions and that the radar showed little or no returns. When asked to hold altitude, the pilot asked to climb out and did so by making a U-turn at the southeastern end of the low reflectivity patch. Overall, NW 272 appeared to be within the patch of less than 10 dBZ reflectivity at altitudes at or below 7000 ft for more than 8 minutes.

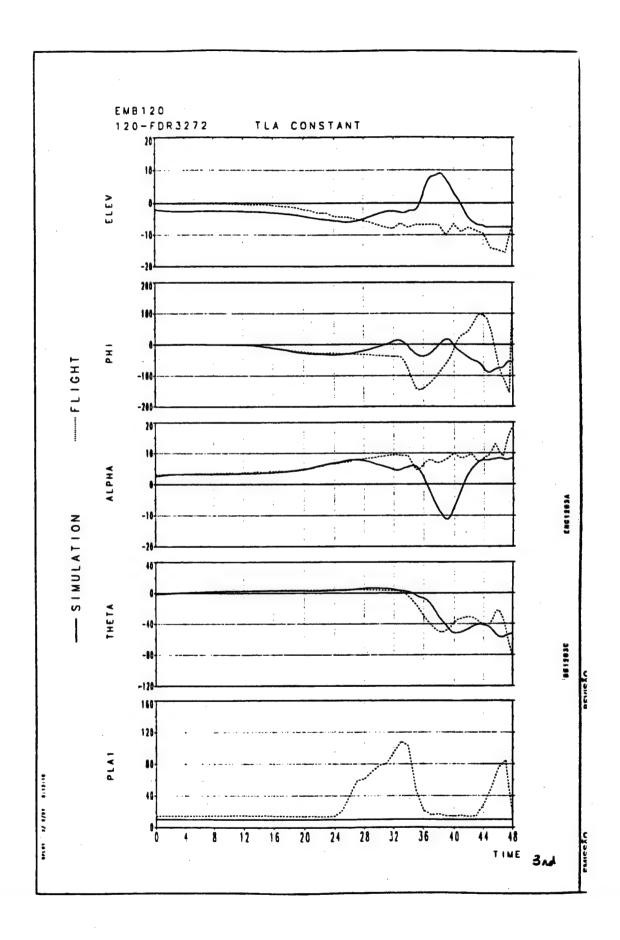
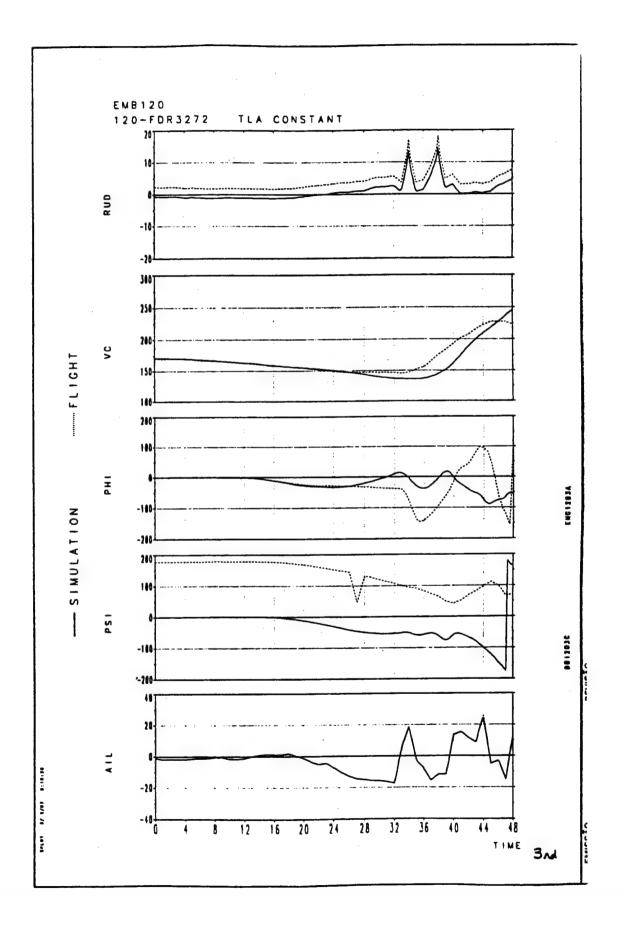
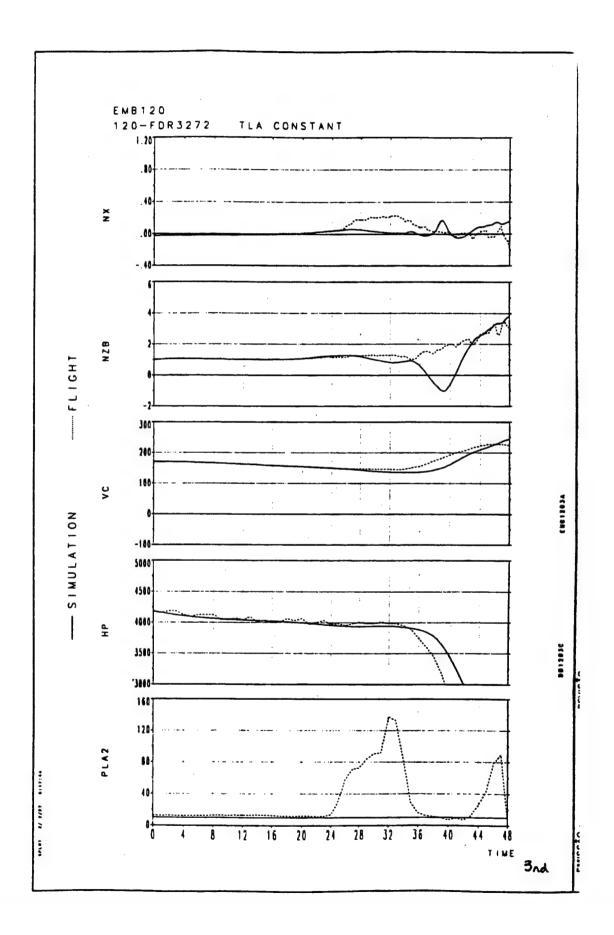
The attached figures (3 pages) shows the airplane response without power increase from the simulation and the DFDR readings. In figure 2 we notice that the airspeed that in the DFDR readings shows a flattening around 150 Kcas, but in the simulation it has a constant decrease up to a minimum of around 135 Kcas. It is important to notice that at this moment the angle of attack (AOA) of the DFDR is increasing rapidly and the drag variation that was introduced in the simulation is also increasing from a value of zero for one degree of AOA to a value of DCD = +0.040 (400 drag counts) for 10 degrees of AOA. This value of 400 drag counts is almost twice the drag of the airplane landing gears. For those reasons (the fact that without increasing the torque the airspeed would constantly decrease and the drag was increasing with the AOA) the airspeed did not show an increase in the DFDR.

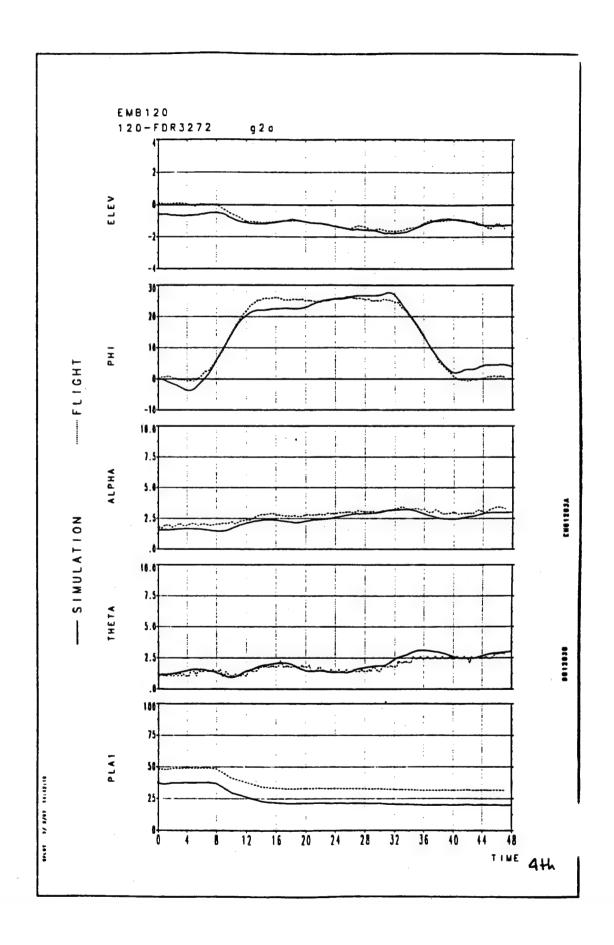
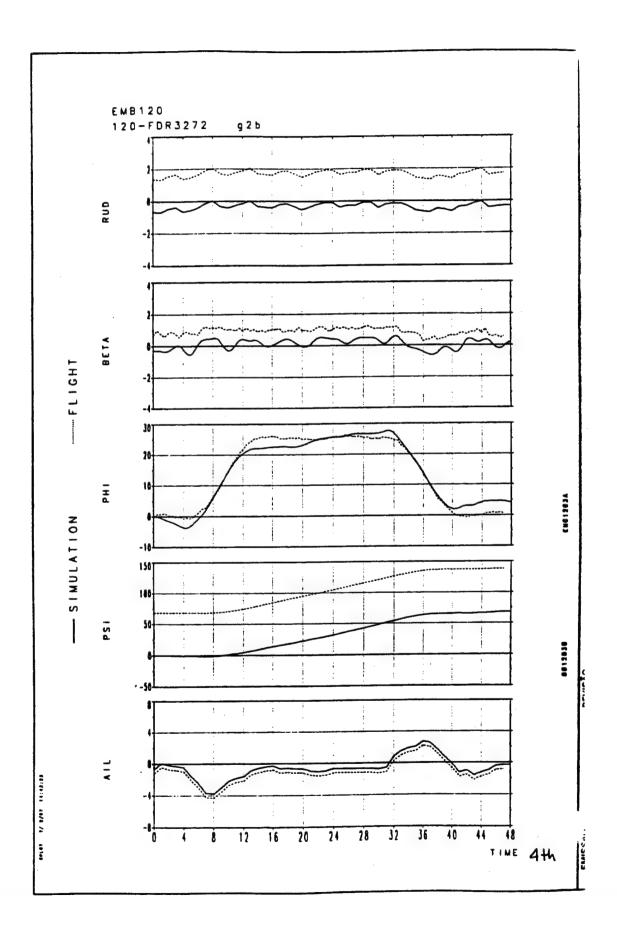
The attached figures (3 pages) shows the comparison of the DFDR readings with the simulation for the same control inputs for the ailerons and rudder. For the elevator, due to the fact that the simulation pitch response is sensitive to small elevator inputs, a simulated autopilot was used to follow the pitch from the DFDR and the obtained elevator deflection in presented in figure 1 with the elevator from the DFDR. We notice that the two values are very similar and only a small trim difference (around 0.8 deg) was obtained.

The obtained simulation roll angles have some small differences at the beginning and the end of the turn, but the average value is very close to the DFDR. It is important to notice that the simulation does not take in consideration several effects like atmosphere disturbances, control cable elasticity, airplane flexibility among others. The accuracy of the DFDR readings and calibration must also be taken in consideration.

We notice, however, that the general response of the simulation is very close to the DFDR readings, suggesting that the aerodynamic data bank is representative of the airplane and, at that moment, no aerodynamic degradation was evident.

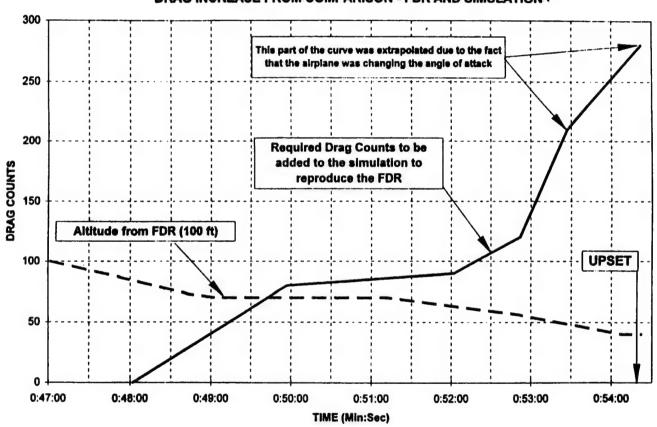
FIGURE 5 - COMAIR FLIGHT 3272
DRAG INCREASE FROM COMPARISON - FDR AND SIMULATION •

The analysis shows that the aerodynamic degradation started near DFDR time 48:00 and lasted for about 6 minutes. The increase in drag is not linear with time or altitude and a small variation is noticed during the period of time from 50:00 to 52:00. After that, the rate of increase in drag is pronounced, particularly between 52:50 and 53:30.
